3813 North Hermitage Avenue, Chicago, IL 60613

Single Family Residential

propertylens Snapshot

Report Date: 07/23/2025 Report ID: 61dc32c5-03bb-4396-a2a5-e0cad607f649 Address: 3813 North Hermitage Avenue, Chicago, IL 60613 APN: 14192140180000

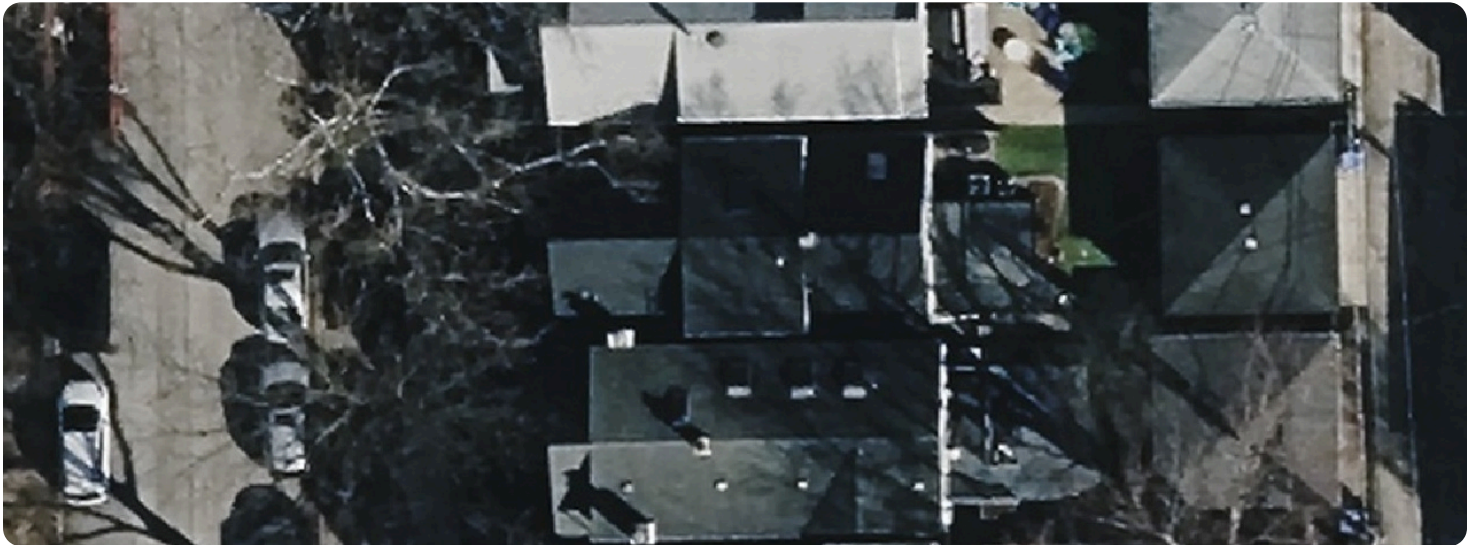
Primary Building

Roof Condition: Good

4 out of 5

Roof is in good condition - Minimal signs of defects. Defects are cosmetic and do not affect the function and safety of the roof.

Low risk of damage to roof. The following factors contributed to this score: low tree overhang, roof in good condition.

Tree Overhang	1%
Missing Shingles	-
Ponding	-
Debris	-
Staining	-
Algae Staining	-
Vent Staining	-
Tarp	-
