1. Identification / recognition

KAN-SV1-RS-B-5-202409

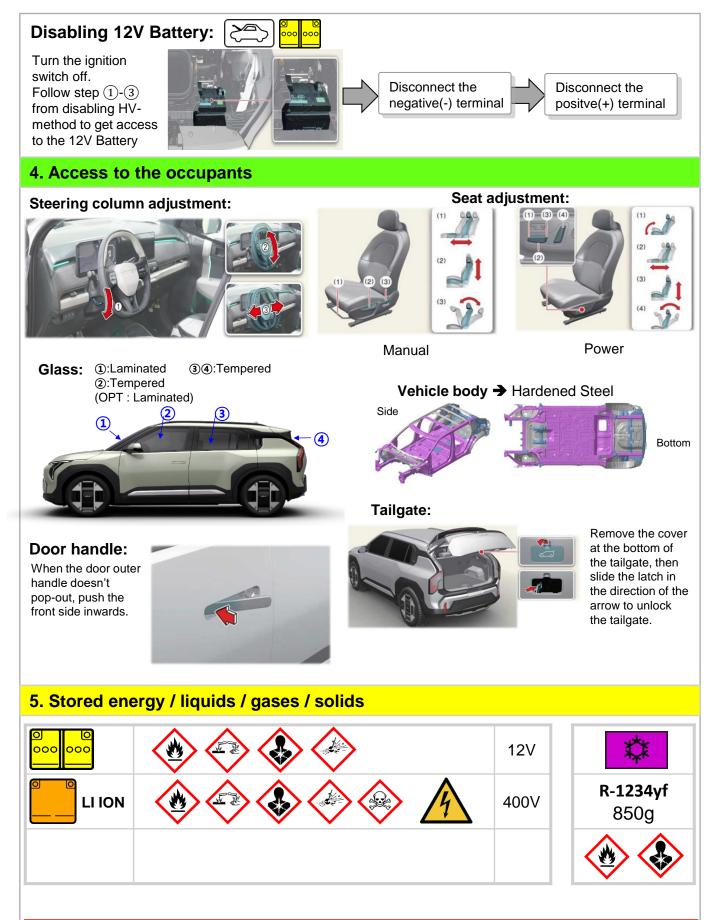
WHEN COOLANT LEAKS FROM THE BATTERY PACK, IT CAN BECOME UNSTABLE WITH RISK OF THERMAL RUNAWAY. CHECK BATTERY PACK TEMPERATURE WITH THERMAL IMAGING CAMERA

Do not touch any of the high-voltage components or cables including the high voltage cut-off switch, as doing so poses an electrocution hazard. Work on the vehicle only after the vehicle has been pulled out of the water.

Notice: The use of wheel dollies or flatbed is recommended. Use a wheel lift or flatbed equipment.

Notice : Do not tow with slingtype equipment (1). Do not tow the vehicle with the front wheels on the ground as this may cause damage to the vehicle (2).

Towing hock located in the tool case in the tailgate

The hook must be used only temporary towing. Store at safe distance from other vehicles
